Project/File: CIAR# 80100

Impact Assessment Agency of Canada

**Reference: CN Milton Logistics Hub July 15<sup>th</sup> Incident 30-Day Report**

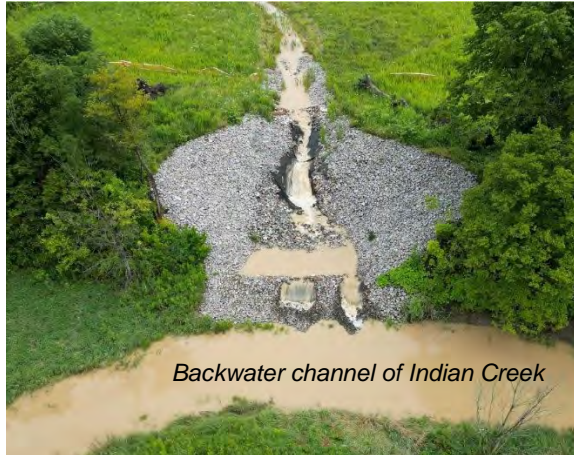
During a storm event on July 15, 2024, heavy runoff from the CN Milton Logistics Hub site caused damage to the existing surface water outlet from the Regional Diversion Ditch located downstream of Culvert 3. The storm flows caused existing rip-rap material to be displaced from the spillway and deposited within the plunge pool at the base of the slope. As a result, the geotextile filter cloth beneath was exposed, and sediment-clouded water was observed entering the backwater channel of Indian Creek. Due to wet and unsafe conditions, Dufferin Construction Company ("the Contractor") was unable to access the slope to immediately stabilize the area.

Photo 1: Spillway slope failure

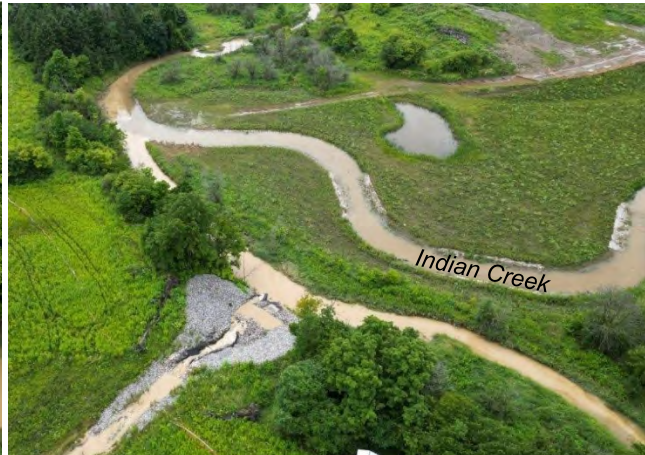
The initial observation on July 15, 2024, was made during a routine turbidity monitoring inspection by CN's Environmental Monitor (EM). Upstream readings were recorded as 15.2 Nephelometric Turbidity Units (NTU) while the downstream readings were recorded as 48.2 NTU. This higher downstream reading prompted further investigation by the EM to determine the cause of the elevated turbidity, during which the washout to the spillway was identified. At that time, sediment-clouded water was observed entering the backwater channel of Indian Creek at the spillway before entering the main channel approximately 50 m downstream. Water quality in the receiving watercourse was also observed to be turbid at that time, as a result of non-project-related storm-induced erosion upstream.

Photo 2: Sediment-clouded water entering Indian Creek

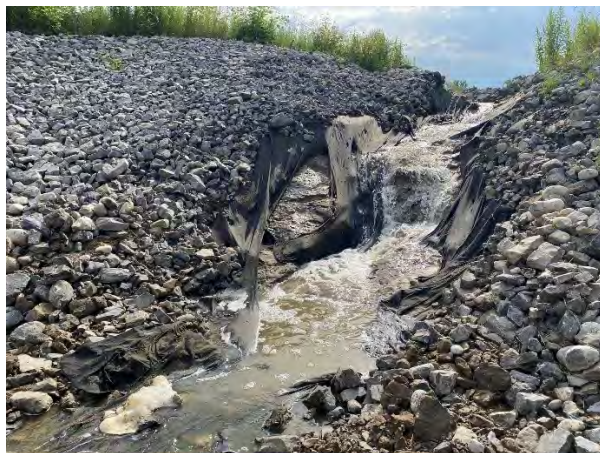
Further damage to the spillway was observed following a larger storm event the following day, on July 16, 2024, where additional rip-rap material was observed to have been displaced with additional geotextile filter fabric exposed and torn in some areas, leaving sections of exposed earth underneath.

Photo 3: Exposed and torn geotextile fabric

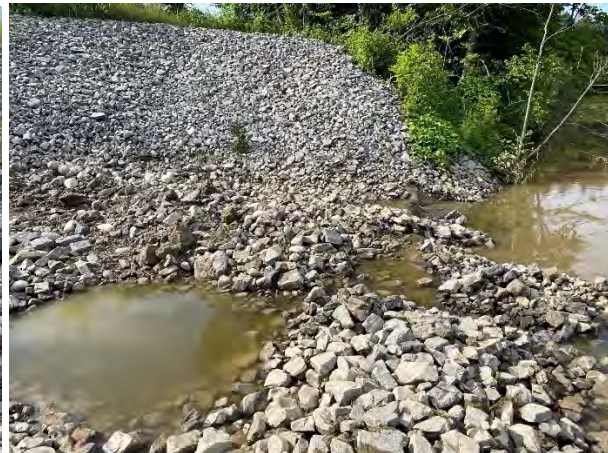
Photo 4: Displaced rip-rap deposited in plunge pool

- Reconstruct and remove all rip-rap material that has been displaced into the plunge pool.
- Reconstruct the plunge pool and place rip-rap material on the lower portion of the spillway.

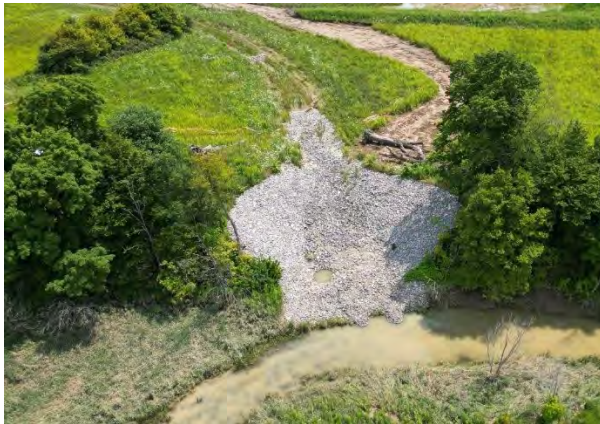
Photo 5: Temporary repair to the spillway

As soon as conditions were safe after the storm events, the contractor was able to gain access and stabilize the slope temporarily. Vegetation was cleared following a nest sweep, and temporary access to the site was constructed to enable repairs to be undertaken. A mini excavator was used to bring in rip-rap loads by the bucket on July 17<sup>th</sup> and 18<sup>th</sup>. This rip-rap was placed on the slope to stabilize the bank.

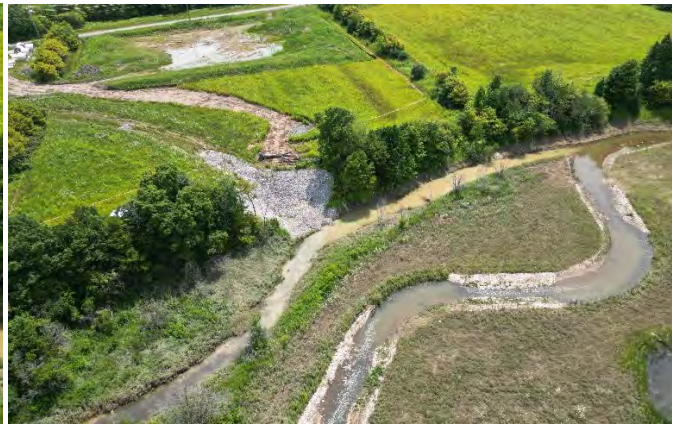
Photo 6: Sediment-clouded water in the backwater channel

Subsequent NTU readings were taken on July 18 and 22, 2024, after the temporary repairs. Both NTU readings were below the acceptable thresholds when comparing upstream to downstream readings; however, water in the backwater channel of Indian Creek still appeared to be turbid. It is anticipated that these conditions are the result of sediment-clouded water entering this backwater channel during the July 15 and 16 rain events, although turbid conditions had not yet fully settled or flushed out. Secondly, observed carp activity may also have been contributing to these continued turbid conditions.
