Project/File: CIAR# 80100

Reference: CN Milton Logistics Hub July 15th Incident 90-Day Report

The following photos depict the spillway remediation work that was completed in August 2024.

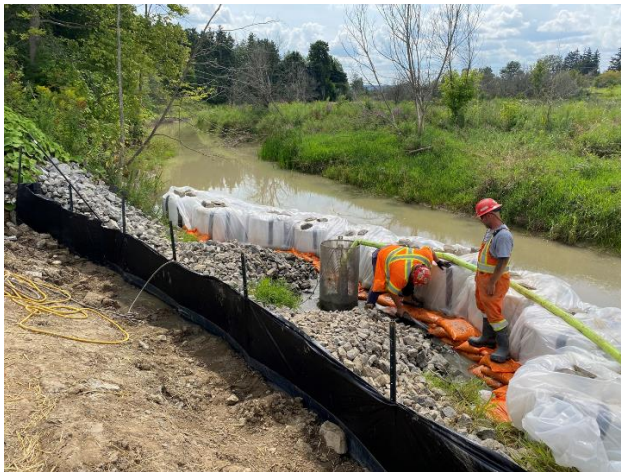
Image 1: Cofferd Dam installation and fish rescue at outlet of spillway within the Indian Creek backwater channel

- A temporary meter bag coffer dam at the outlet of the spillway was installed within the backwater channel to isolate the work area. Dewatering of the work area occurred within the coffer dam to gain access for the remediation work. A fish salvage was conducted by Stantec biologists within the isolated portion of the backwater channel of Indian Creek (in accordance with Condition 7.2).

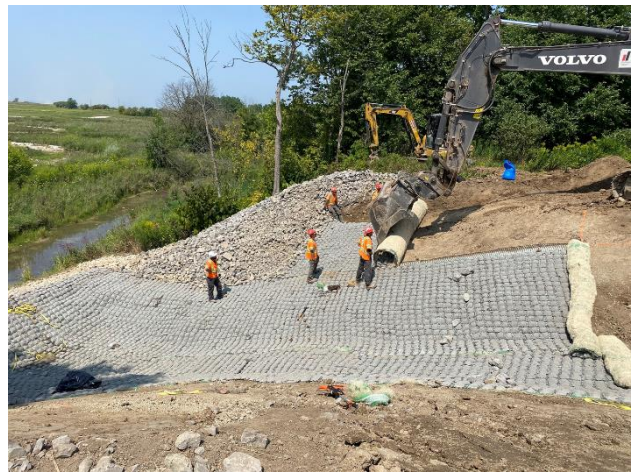
Image 2: Installation of Terrafix Flexamat protective barrier

- Filter cloth and rip-rap were replaced along the banks of the spillway and lower portion of the plunge pool.
- Terrafix Flexamat protection barrier was installed from the upper-middle portion of the spillway down to the bottom of the slope and within the plunge pool.

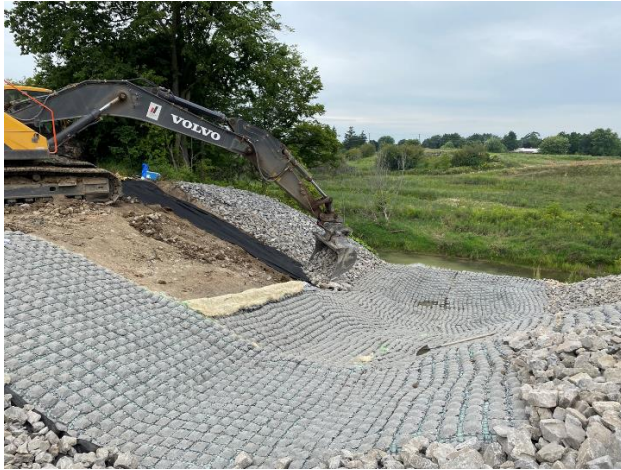
Image 3: Installation of filter cloth and rip-rap material along the banks of the spillway

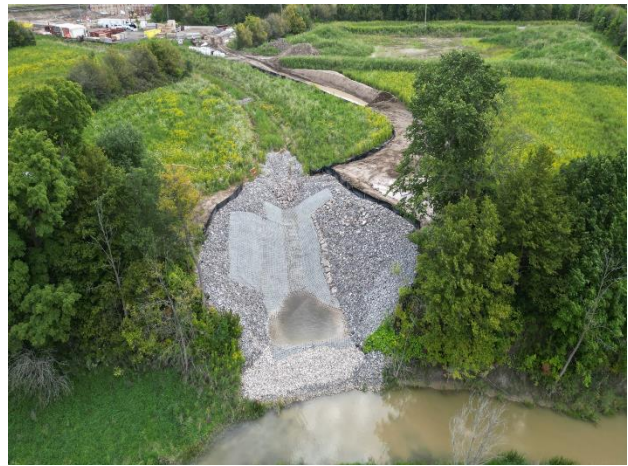
Image 4: Completed remedial work to the spillway prior to temporary access road being decommissioned and restored

- Any exposed areas were reseeded, and the temporary access road was decommissioned and reseeded.
- Silt fencing will remain in place and maintained until all exposed areas are sufficiently stabilized.
